**RE:** Building Inspection of Storage Facilities at 16 Depot Street, Hudson Falls NY

Based on my site "walk-thru" of the Storage units A- B at 16 Depot Street in Hudson Falls this past Wednesday afternoon I am writing this letter (short form) to note my major concerns with those units. Below are attached photos; however I would acknowledge as discussed while there were also other concerns, the issues outlined below are the most serious.

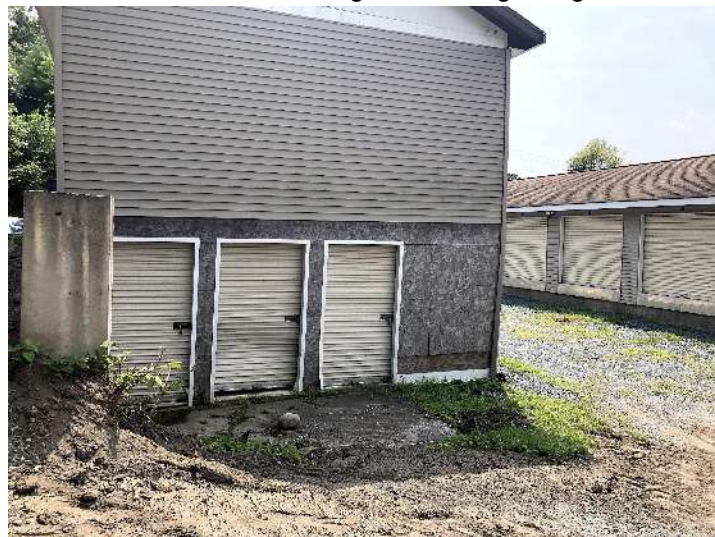
**I** - Unit B – gable end garage doors were severely damaged and inoperable; requiring complete replacement, which includes rebuilding those door frames. As shown in the photo there is also an issue with water drainage at that end of the building and I believe has contributed to this condition.

To successfully eliminate the current water drainage issues, the current concrete foundation retaining wall would require extending and re-grading of the site soils and installation of underground drainage piping.

- \$ 400 per door x 3 = \$ 1,200
- \$ 800 for concrete retaining wall extension
- \$ 1,600 for building end site regrading and underground drainage.

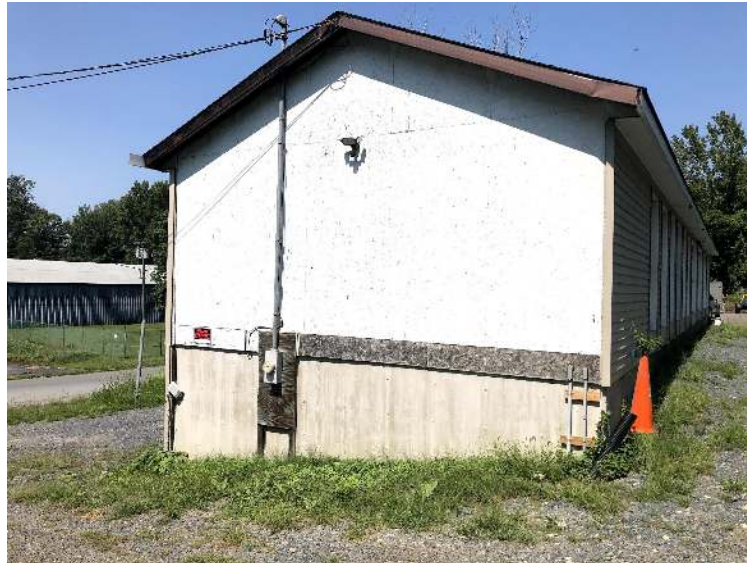
**II** - Unit A – the South gable end and east side of this unit displays water drainage issues impacting the foundation wall below. This is evident in the storage space below at this end (see photo). The structural crack as witnessed is the result not only of water at the gable end of the building but also the water buildup between the units A and B (east side of Unit A). The siding missing from the south end along with soffit and fascia damage and trim degradation, contributes to the degradation of the building sheathing. There is currently no weatherproofing of the building frame and structure; this is problematic.

I believe site regrading between these two units with underground drainage piping along the south end of the building will not only relieve the pressure on the foundation wall; but also help to eliminate water intrusion currently present in those lower levels.

\$ 5,800 for site regrading / under-ground drainage piping down along south end of Unit A towards Depot Street. I calculated approximately 2,400 sq. ft. at a cost of \$ 3,500.  
\$ 1,600 for gable end siding & incidentals repairs to wall sheathing.  
\$ 1,800 for aluminum fascia and soffit repairs / replacement.

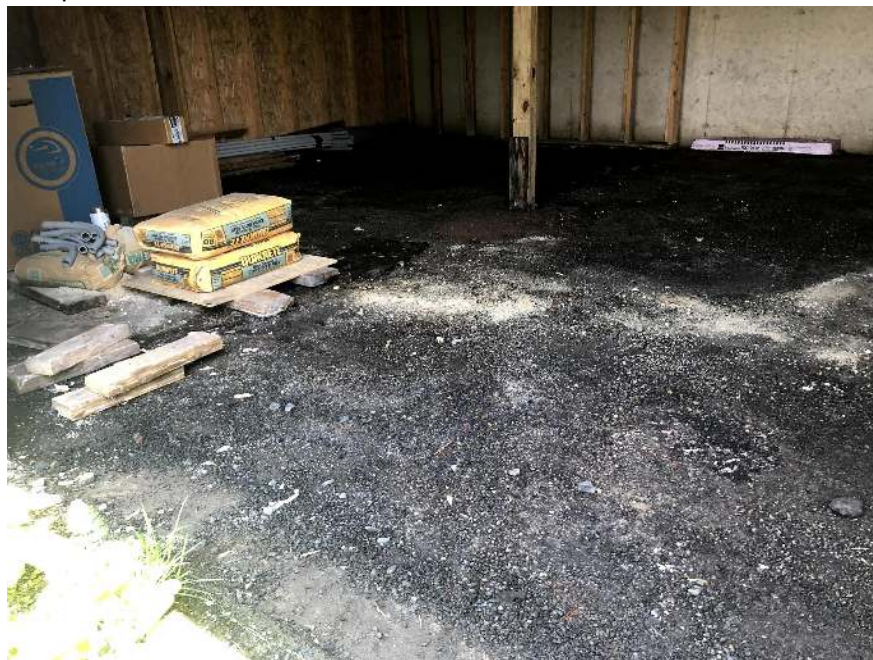
III - Units A – lower-level storage units exhibit floor slab surface damage from ground water and water migration from grades above between storage Unit A and B. The lower level units will require existing paving and incidentals removed and new asphalt paving installed. In addition, the stud wall separations and posts which are present (see photo) will require the sill plate cut out and replaced with pressure treated wood sill and the post cut back with a new post base installed – to insure no further degradation of these structural members.

\$ 6,400 for lower-level slab removal and re-paving.  
\$ 4,800 for wood walls and post structural re-work
